Engine Leaks and Cures

Technical Restoration Clinic presented 11/18/2010 (updated 3/27/13)

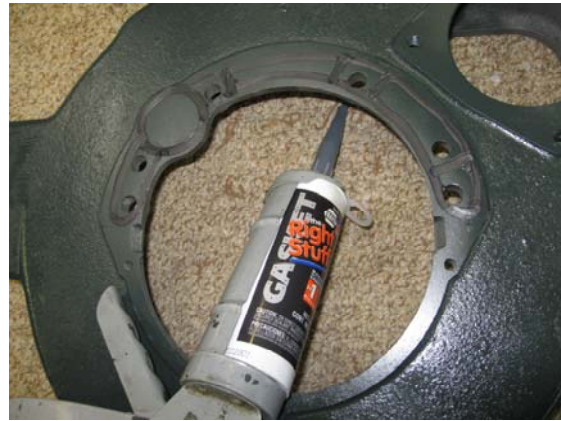
Option: Omit the gasket & shims and use a good quality gasket replacement sealant.

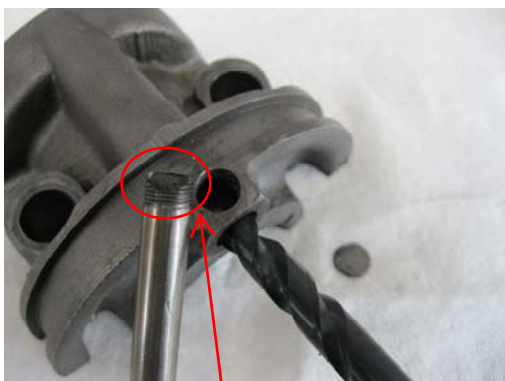
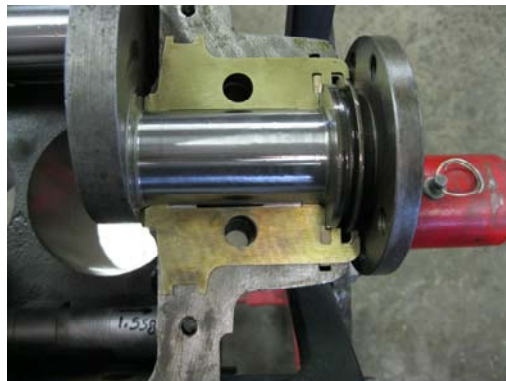
Note area removed to allow oil to pass freely to drain pipe

*E. Check oil tube on rear main cap that it is not missing, broken or cut off. The end of this pipe must be in oil in bottom of sump. If pipe is not in oil, pressures in crankcase will blow oil out rear main. If pipe is screwed into cap too far this will restrict oil flow back to sump and cause rear main leak. **(See photo below of modification to pipe at the threaded end.)** The oil galley plug in rear main should be installed again to stop crankcase pressures from pushing oil out rear main. Next remove rear main cap, oil galley in cap must be open and clean so oil can flow back to sump. With cap removed from engine you can now inspect Babbitt for wear, cracks chips, ECT. The last quarter inch of the bearing must be full diameter of Babbitt no cuts, grooves or chips. Shims must fit tight to crankshaft. **(See photo)** Plastigage can be used to check bearing clearance at this time with engine still in car. I suggest a jack be used to apply pressure upward on crankshaft. This will seat crankshaft up into bearings in block to give you an accurate measurement. Desired clearance is .001 to .0015.*

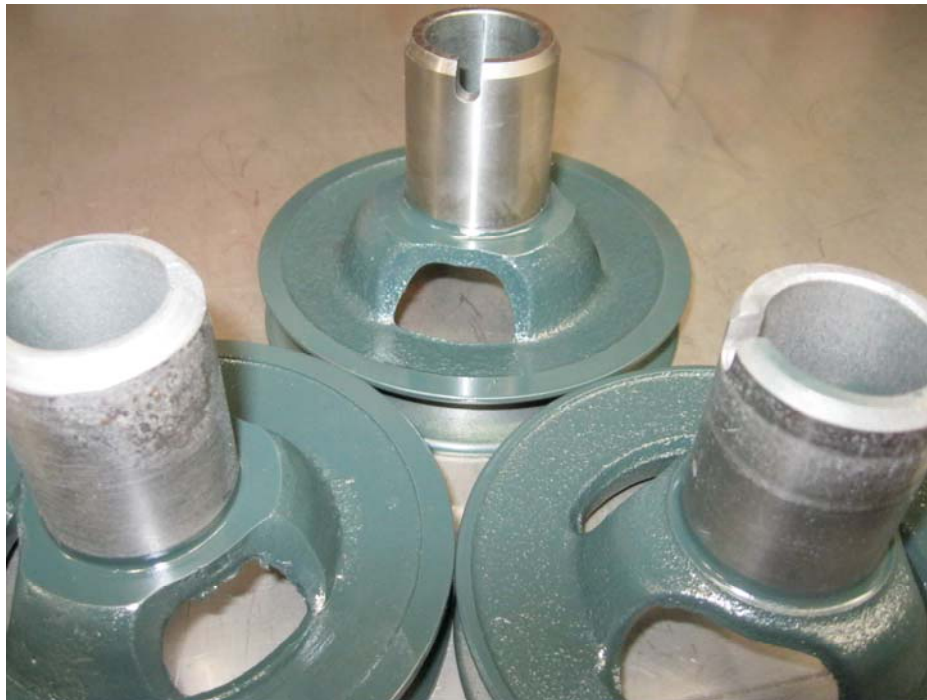
The pulley on the left is new and prior to polishing. The upper center is a new pulley polished and ready for use. The right pulley is a used pulley showing a slight wear area from the seal packing, it could be re-used with an original style packing but not with a modern seal.

Front seal and pulley: The original style front seal presses heavily on the surface of the pulley and with time, the packing and metal wear away leaving clearance for oil to pass. If leaking in this area, a new seal alone may fix the problem but it is advisable to also replace the pulley. The pulley surface the seal presses on needs to be very smooth. Many of the new pulleys from suppliers will require polishing with fine emery cloth to remove surface defects. The following picture shows the varying conditions of two new and one slightly used pulley.

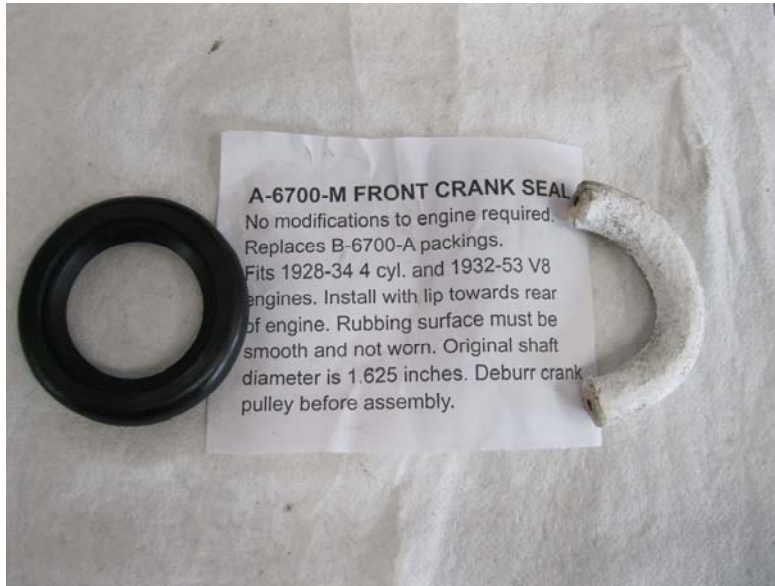
The picture below shows a modern seal offered for the front pulley area that requires no modification to original engine components. The original style packing is also shown.

It is critical when using the modern seal to have the surface of the pulley polished and to have a full diameter of 1.625 inches for the seal to function properly. The modern replacement seal is leakless when installed properly. The photo below (left pulley) shows the slight wear that is acceptable when using an original packing. I am currently using original packings when assembling rebuilt engines.

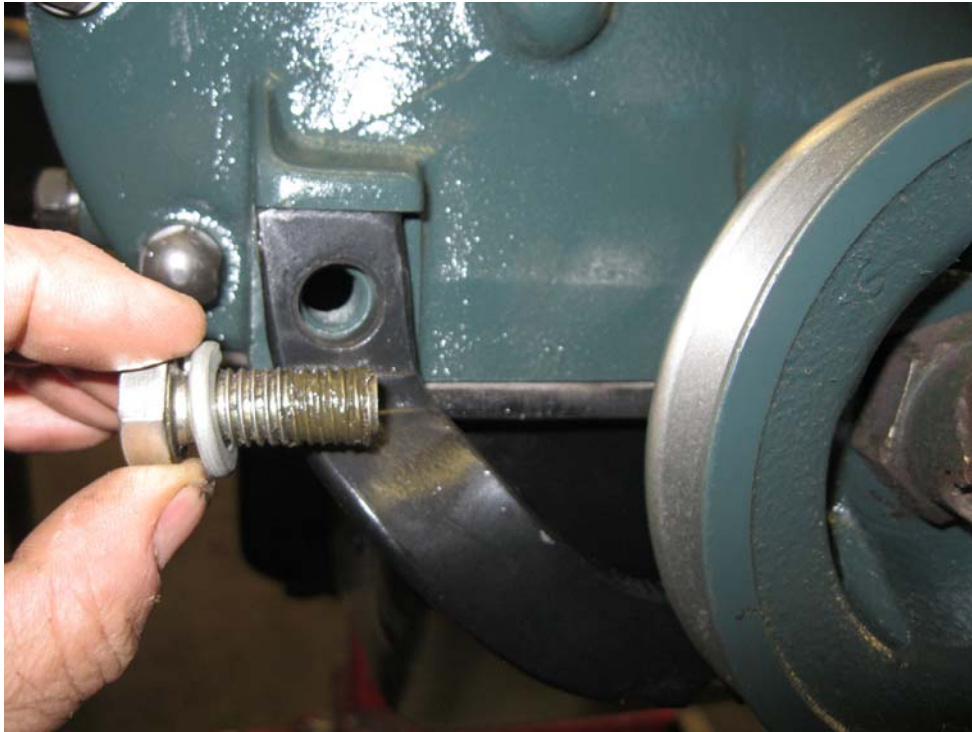
Use just enough sealant to seal the threads in the tapped hole.

The front engine support yoke passenger side bolt is a source of leakage often overlooked and blamed on the front seal. This threaded opening in the front timing cover is open to the crankcase. A ring of Permatex #2 on the threads will seal the area.

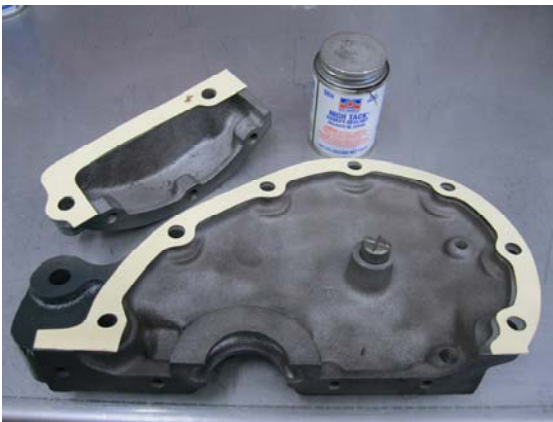
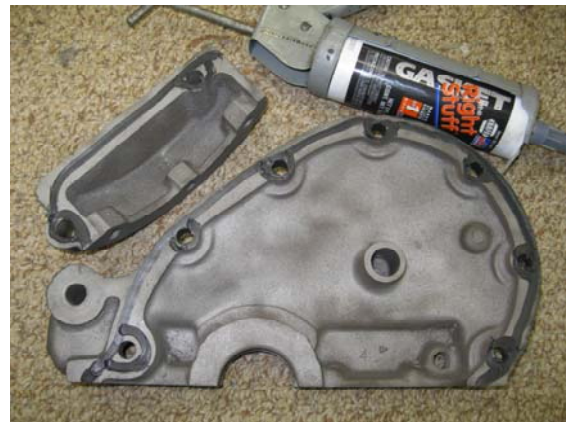
The timing covers came from the factory with thin paper gaskets. If these gaskets are used, they should be coated with Permatex #2 on both sides. I often do not use these gaskets when assembling engines. I use a good grade automotive gasket sealant in place of the gaskets as shown in the photo below when omitting the gaskets. Permatex Right Stuff is an excellent sealant to use in lieu of the gaskets.

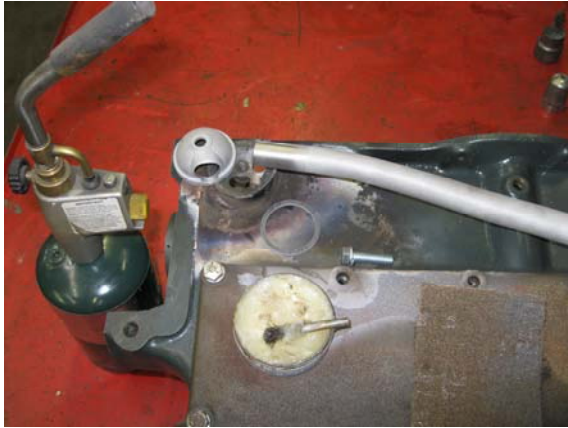
Cleaned parts prior to fluxing

The external return oil pipe is often a source of a leak due to misalignment of the ends or an actual crack in the solder used to secure the components from the factory. You can use an old block as a jig to accurately locate and re-solder the ends. The components must be very clean to obtain a strong joint.

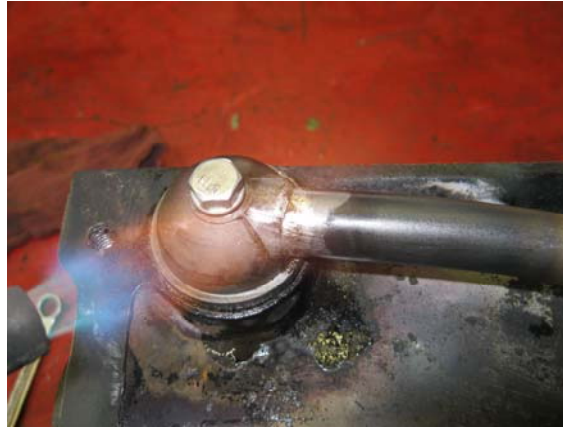
Heat the parts...not the solder

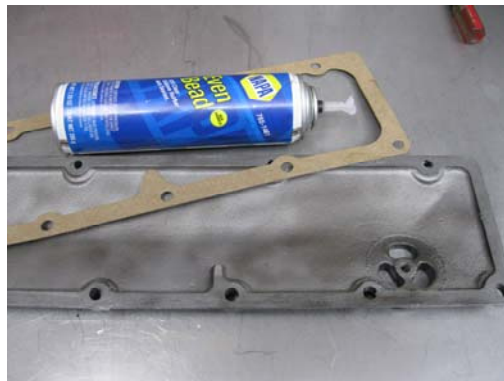
The valve chamber cover can be a source of leakage. Seal your choice of gasket to the cover with Permatex #2. When applying, spread the sealant around the bolt holes also. Install the gasket and cover on the engine with all the bolts to position and clamp the gasket to the cover while the sealant sets. When set, remove the cover and apply a coating of high temperature chassis grease to the gasket or valve chamber opening edge and re-install. The grease will keep the oil from seeping and will allow for future removal of the cover without damage to the gasket. Be careful to avoid over tightening the valve chamber cover bolts or the cover will crack. Cork gaskets require much less torque than paper gaskets. If using silicone, use a very thin coat and wipe or cut away any excess. (Be careful...small bits of silicone and bearings do not work well together.)

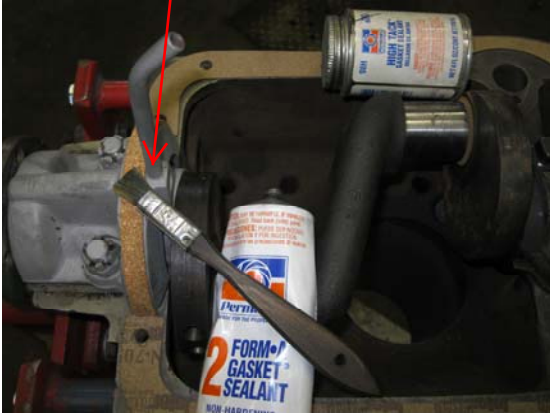
Typical sealants

A small paint brush with the bristles cut short works good for applying the Permatex

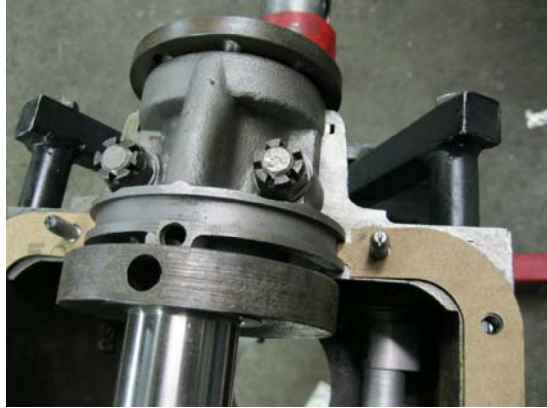
Pre-fit pan gaskets dry

7. *Dry fit the oil pan gasket and make the necessary adjustments for the holes to line up. Fit the rear cork seal area. There is a tab on each gasket that fits into a groove on the rear main cap. This groove width varies and the tab may need to be trimmed. If using a modern front seal, cut the gasket to fit around the seal.*

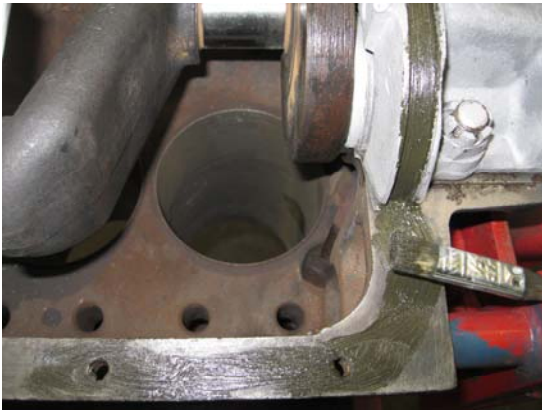
Seal around the pan bolts

15. *Install the rear and front bolts first if possible. Do not pull them down until you have all of the other bolts started. In a random pattern that pulls alternately from side to side, start turning the bolts down. The objective is to pull the pan down evenly. If using a cork gasket, seat the pan to the gasket and turn the bolts another 1/2 turn and stop. If you pull it down tight, the cork may be forced out from between the pan and the block. If using a paper gasket, you can turn the bolts down snug. 20 ftlb torque should be adequate.*

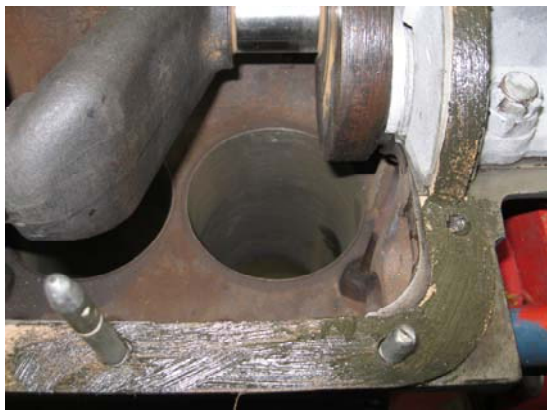
Apply sealant over the rear cap cork

10. *There are two widths of grooves on rear main caps. Some parts suppliers stock both sizes. Obtain the correct width if possible. Coat the rear main groove with Permatex #2 placing more at the ends where the cork will butt to the flat pan gasket and then force the cork gasket into this groove until it seats. You will need to cut the cork gasket to the correct length...be careful to avoid cutting it short. The cork gasket must fit snugly to the oil pan gasket. Coat the outer surface of the cork gasket to provide a good seal to the pan.*
